**DEPARTMENT OF TRANSPORTATION**

Quality Assurance and Source Inspection

Contract #: 04-0120F4Cty: SF/ALA Rte: 80 PM: 13.2/13.9File #: 69.28**WELDING INSPECTION REPORT****Resident Engineer:**Siegenthaler, Peter**Address:** 333 Burma Road**City:** Oakland, CA 94607**Report No:** WIR-017561**Date Inspected:** 17-Oct-2010**Project Name:** SAS Superstructure**OSM Arrival Time:** 700**Prime Contractor:** American Bridge/Fluor Enterprises, a JV**OSM Departure Time:** 1900**Contractor:** Zhenhua Port Machinery Company, Ltd (ZPMC), Changxing Island **Location:** Shanghai, China**CWI Name:** Mr. Yu Dong Ping**CWI Present:** Yes No**Inspected CWI report:** Yes No N/A**Rod Oven in Use:** Yes No N/A**Electrode to specification:** Yes No N/A**Weld Procedures Followed:** Yes No N/A**Qualified Welders:** Yes No N/A**Verified Joint Fit-up:** Yes No N/A**Approved Drawings:** Yes No N/A**Approved WPS:** Yes No N/A**Delayed / Cancelled:** Yes No N/A**Bridge No:** 34-0006**Component:** Tower**Summary of Items Observed:**

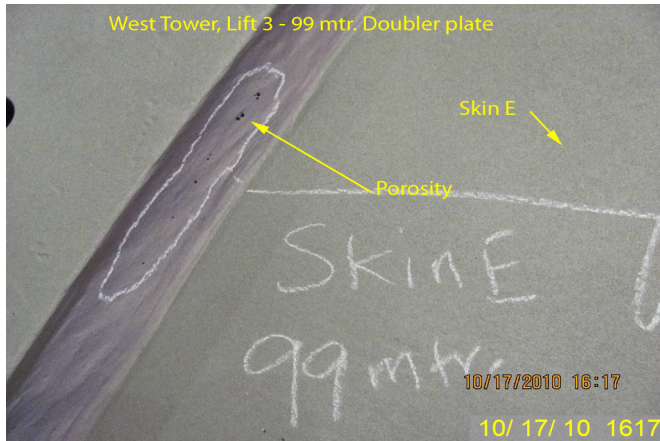
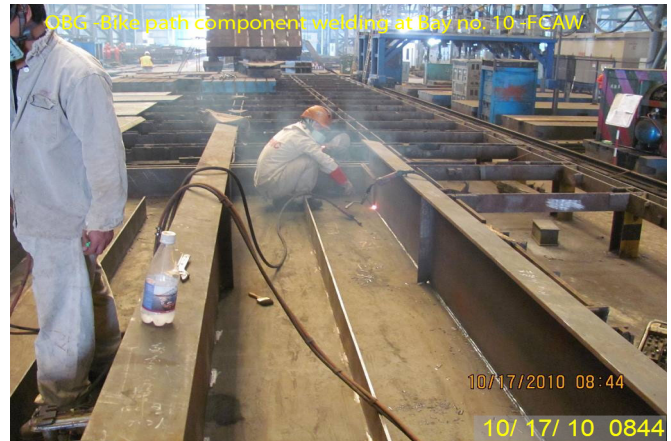
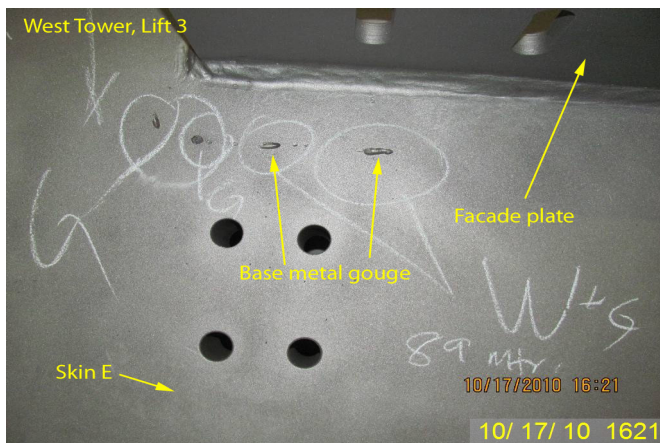
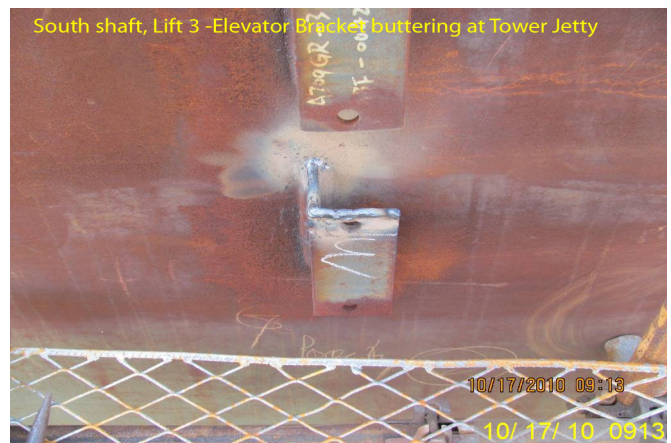
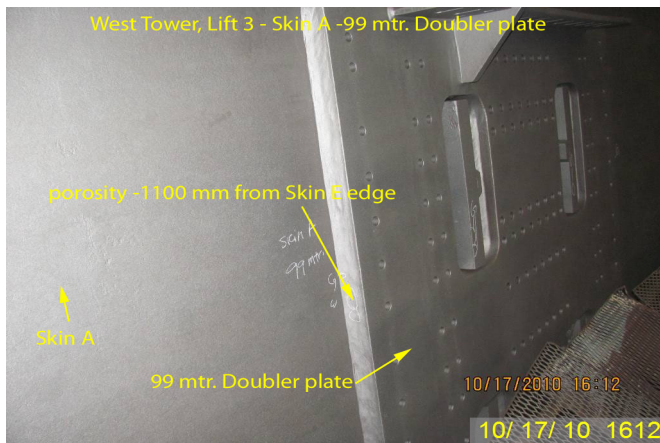
This QA inspector, Baskar Govindarajan, performed Post blast inspection of external surfaces of West tower, Lift 3. All the areas marked which requires grinding, weld repair, Grinding & MT wherever applicable in all the Skins of Tower from 83 to 114 mtr. Elevation. This inspection was carried out along with QA Inspector Mr. Gade (B 307), Mr. Vibin (B 294, Mr. Vikram (B 300), Mr. Pillai (B 286) and Mr. Art Peterson (B 273). All the marked points shown to ZPMC inspector Mr. Zhao Chen Sun and ABF Inspector Mr. Kim. All the weld repair areas (5 nos) marked in weld map in detail and the same was signed by ZPMC and ABF Inspector. Incident report rose for the same.
